Upgrading the SpO2 board from MS-11 to MS-2011

Note: This procedure only applies to devices containing an MS-11 SpO2 board.

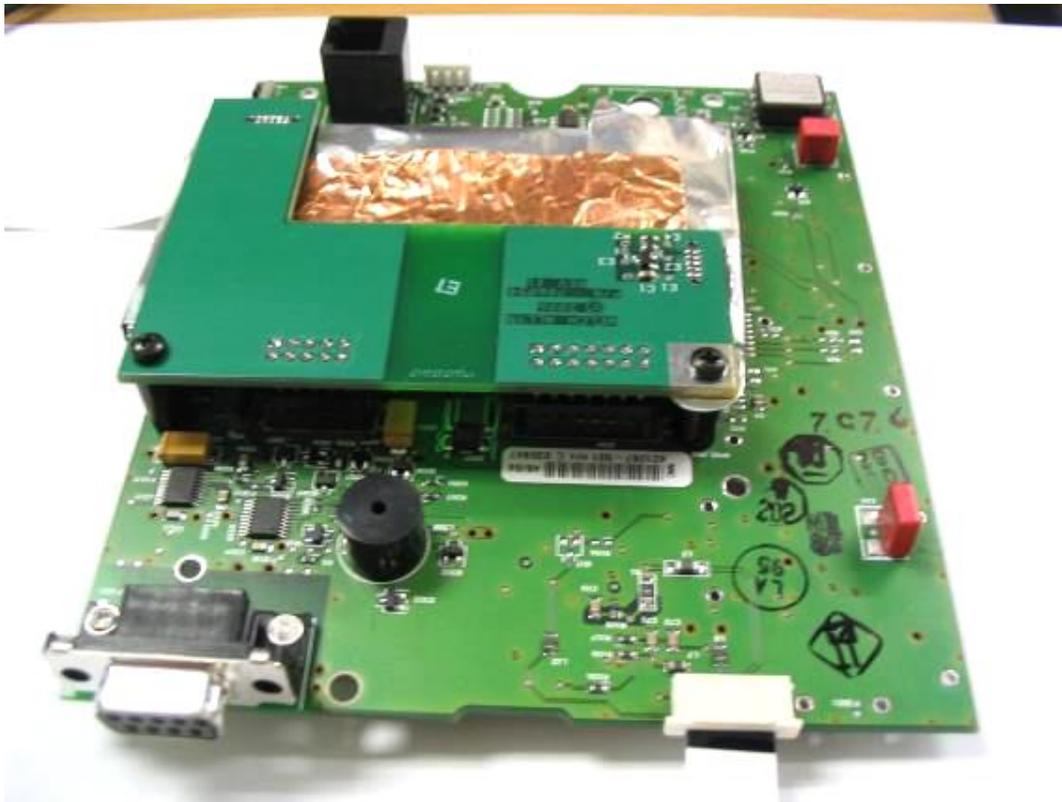
1. Open the SPOT front panel; remove the LCD and the main PCBA, as shown in the standard service instructions.
2. The existing **MS-11** module can be seen wrapped in an EMI shield. The adapter board (403291) can be seen on top of the **MS-11** module.

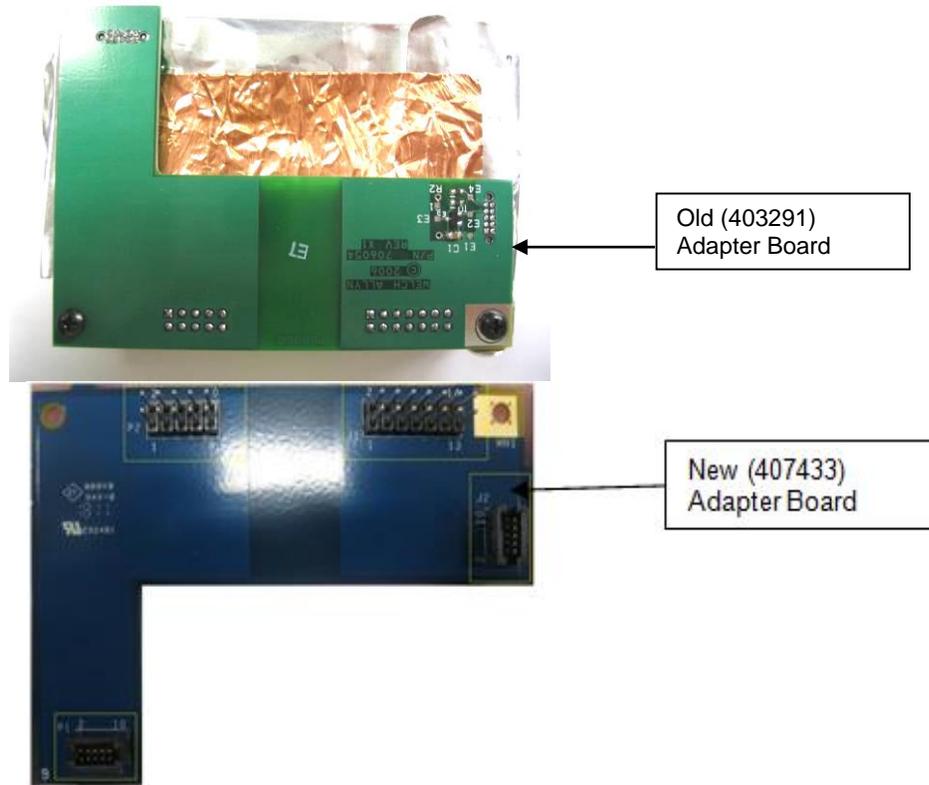
3. Remove the SpO2 assembly. Note the different color between the old green (403291) and the new blue (407433) adapter boards.

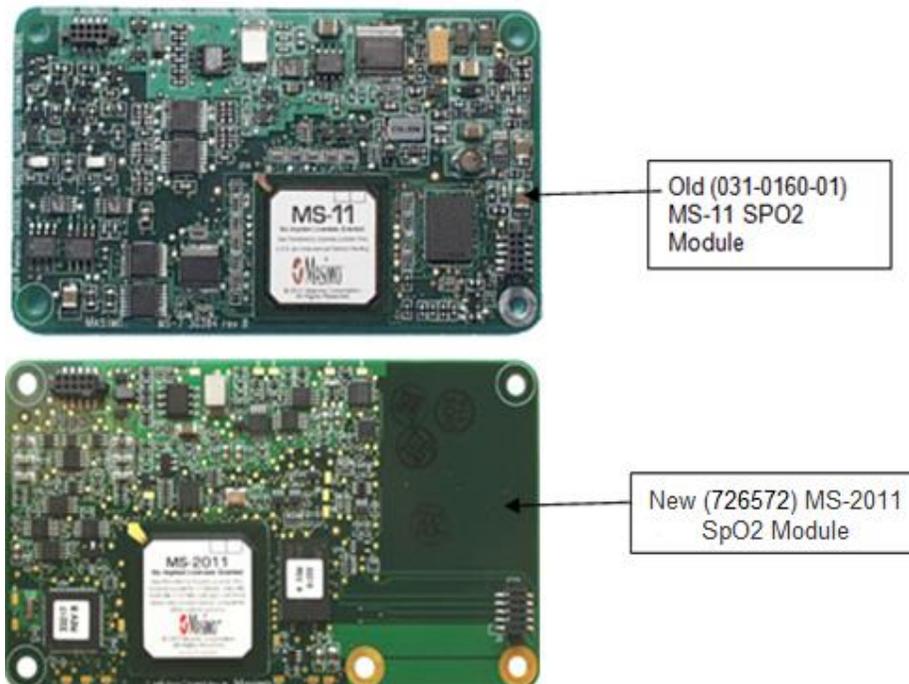
4. Unwrap the EMI shield from the SpO2 Module. Note the difference between the old (MS-11) and the new (MS-2011) modules.

5. Wrap the MS-2011 module in the EMI shield.
6. Assemble the **MS-2011** module into an SpO2 assembly with the **407433** (blue) board.
7. Attach the assembly to the main board and re-assemble the main board in the unit.
8. Re-install the LCD and complete assembly of the unit.
9. For assembly / disassembly details, or to verify proper functionality, refer to:
